13th Generation Intel® Core™, Intel® Core™ 14th Generation and Intel® Xeon® E 2400 Processor

Specification Update

Supporting 13th Generation Intel® Core™ Processor for S, H, P, HX, and U Processor Line Platforms, formerly known as Raptor Lake, Intel® Core™ 14th Generation Processor for S Processor Line Platform, formerly known as Raptor Lake Refresh and Intel® Xeon® E 2400 Processor, formerly known as Raptor Lake-E

Revision 017

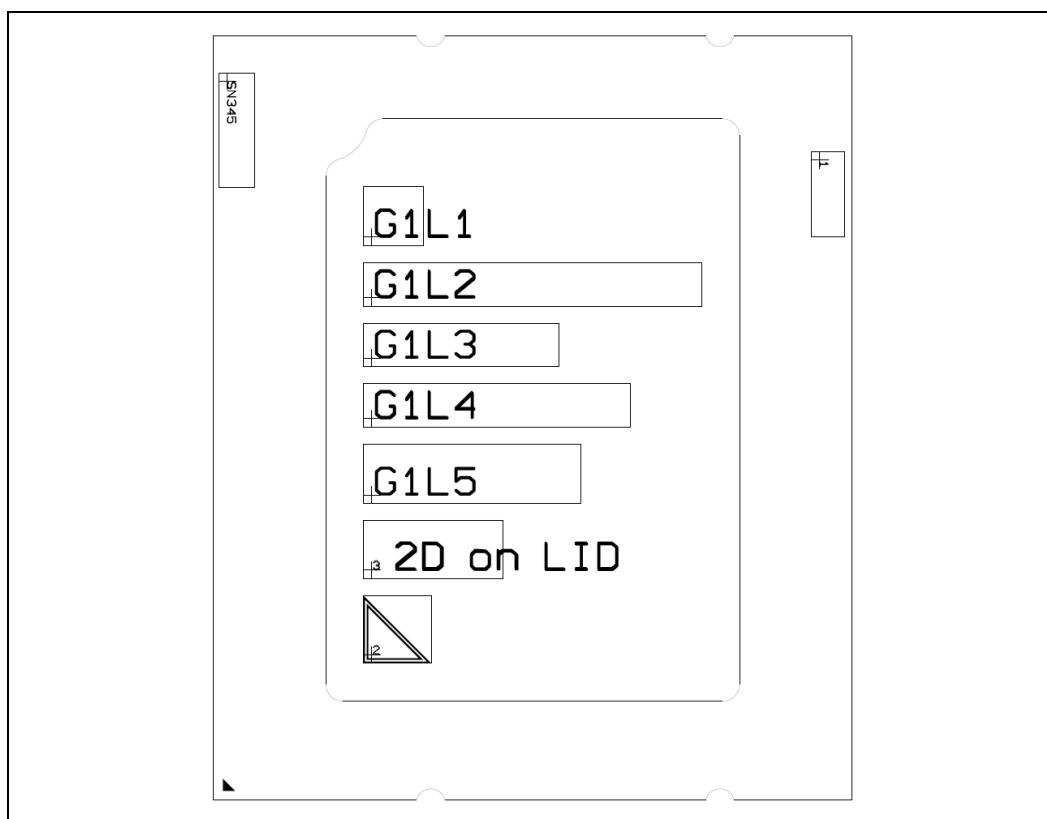
Pin Count: 1700

Package Size (width x height): 37.5mm x 45mm

"2" is Pin 1 indicator on IHS.

Figure 2-1. Processor Based on S/ S Refresh/ E Processor Lines Chip Package LGA Top-Side Markings	8
Figure 2-2. Processor Based on H/P-Processor Line Chip Package LGA Top-Side Markings	9
Figure 2-3. Processor Based on HX-Processor Line Chip Package LGA Top-Side Markings	10
Figure 2-4. Processor Based on U-Processor Line Chip Package LGA Top-Side Markings	11

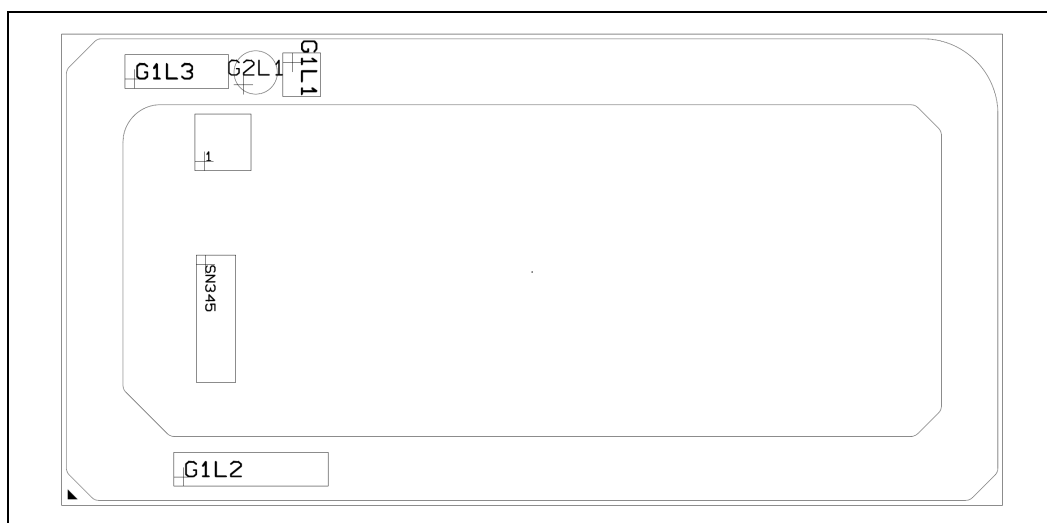
Figure 2-2. Processor Based on H/P-Processor Line Chip Package LGA Top-Side Markings

Pin Count: 1744

Package Size (width x height): 50mm x 25mm

Note: "1" is used to extract the unit visual ID (2D ID).

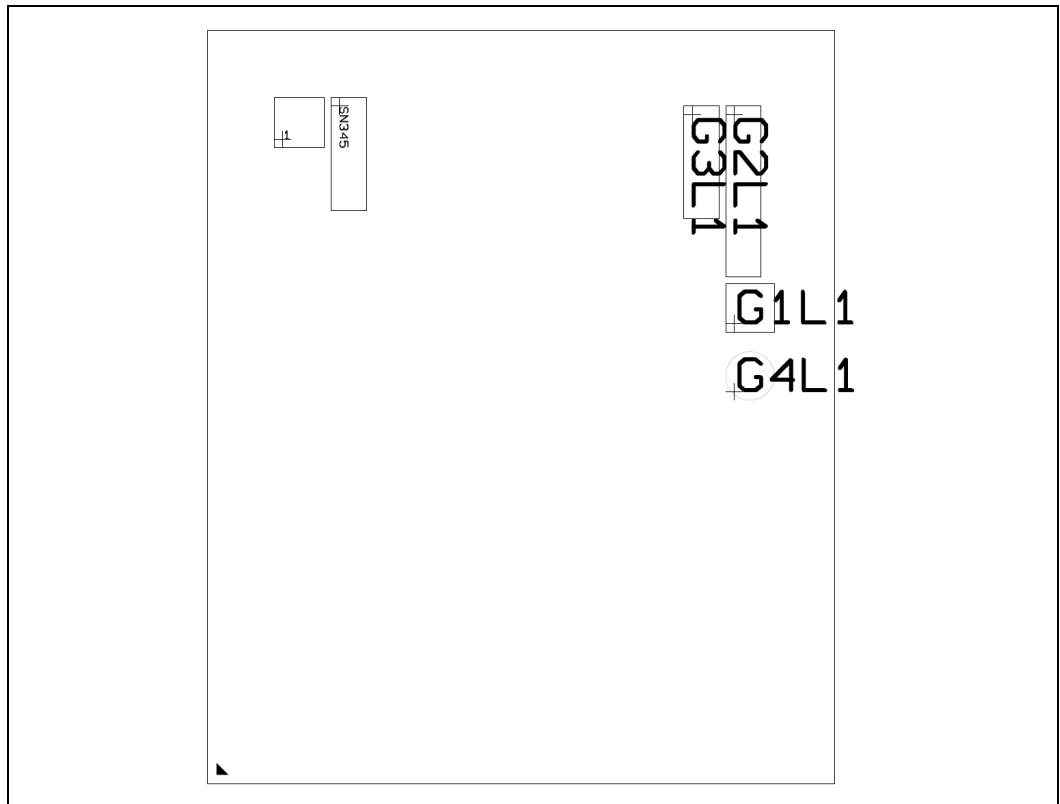
Figure 2-3. Processor Based on HX-Processor Line Chip Package LGA Top-Side Markings

Pin Count: 1964

Package Size "(width x height)": 37.5mm x 45mm

Note: "1" is used to extract the unit visual ID (2D ID).

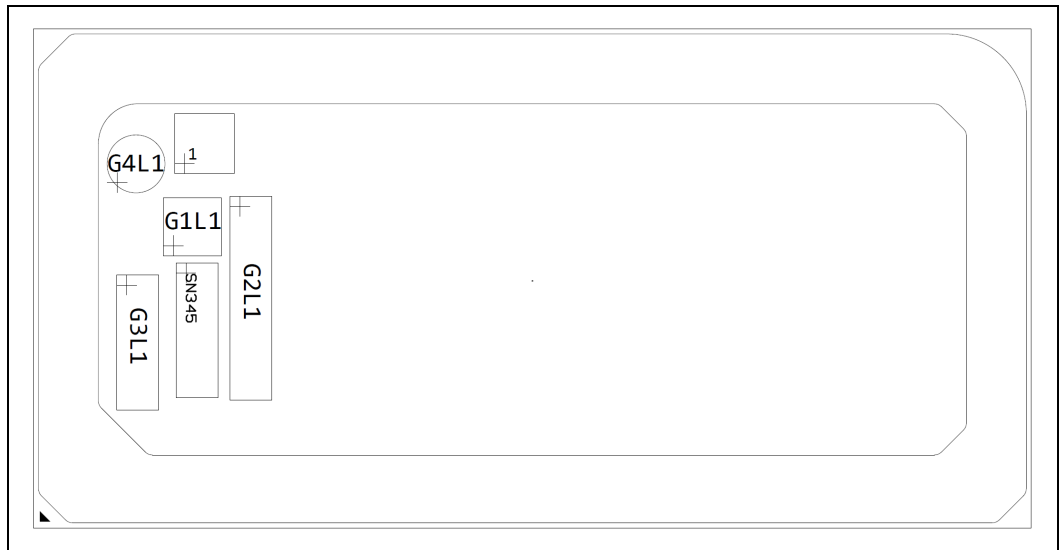
Figure 2-4. Processor Based on U-Processor Line Chip Package LGA Top-Side Markings

Pin Count: 1744

Package Size (width x height): 50mm x 25mm
